Promoting and Installing High-Performance Brakes

Performance brakes require a premium product manufactured to high standards, along with high-quality installation work by the technician. Quality performance parts are never the cheapest. Also, all performance parts are not created equal. Some manufacturers simply put a label on a part and say it's a performance part. Not so with true high-quality performance parts used in this article.

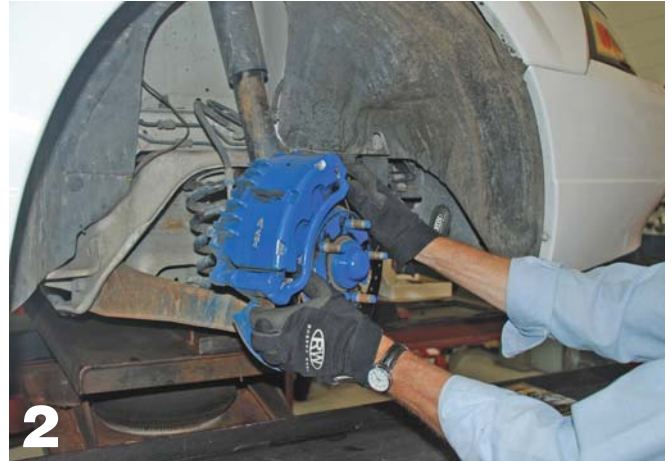
Pretty blue paint doesn't make for a performance-brake system. This caliper has been painted with high-temp paint to look nice but no longer slides as it should. This inability to slide prevents application of the proper brake force to both pads.

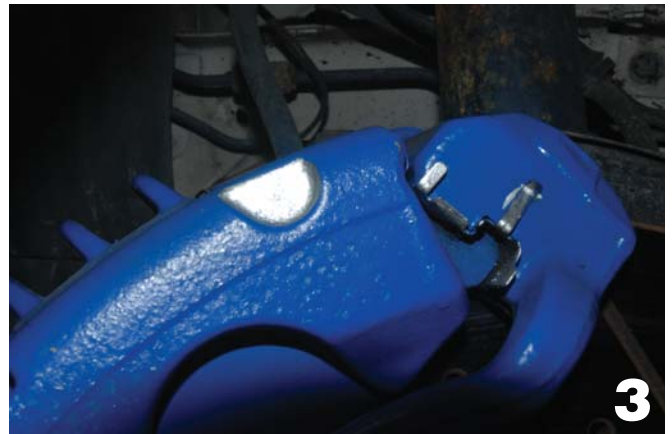
Look closely at the knuckle tension clip. It's clean and silver, but that is because it was brush-painted in place. The paint applied to this brake system hides a problem with the slide area.

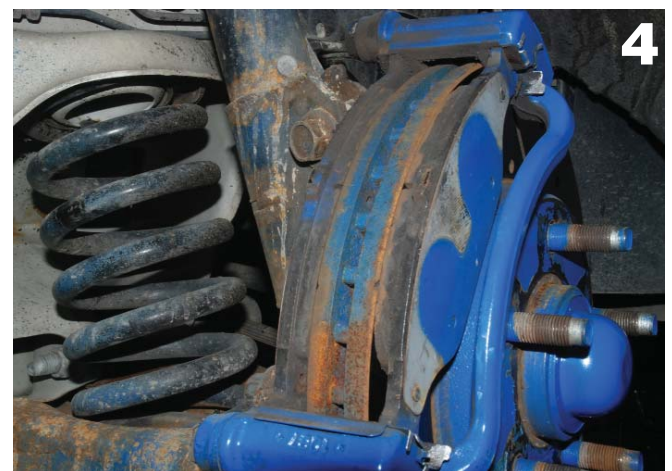
After removing the caliper you can start to see some of the problems present on this brake system. There is no lubricant on the caliper-slide areas, and it's obvious that the brake system was painted while assembled without the critical components being cleaned/replaced or lubricated.

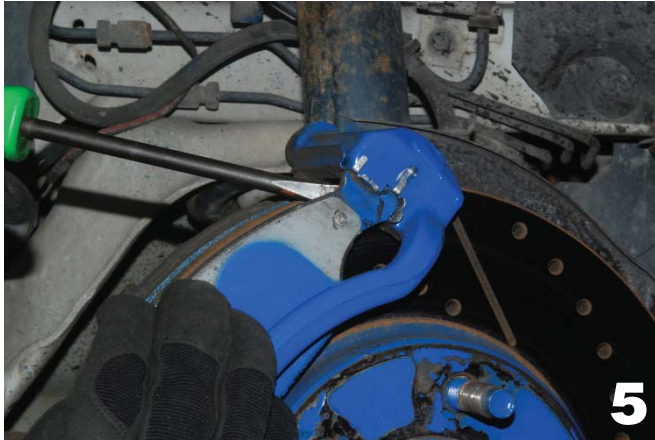
There was so much buildup of rust and other material that the outer pad could not be removed with hand force. It had to be pried out with a screwdriver. This pad obviously was not free to move with normal tip-in application force. Remember that you should be able to install pads with little or no force and move them within their slides with hand force.

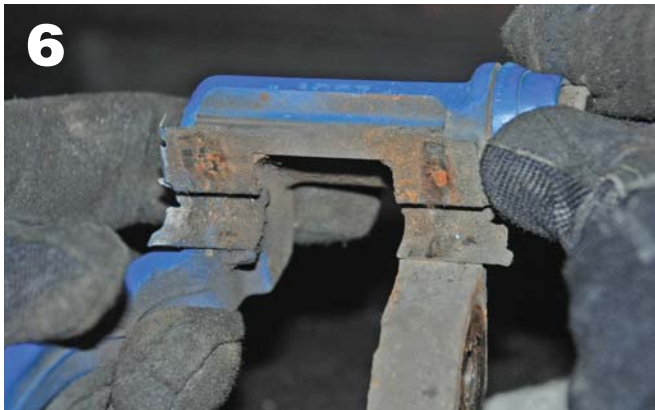
Look closely at the rust and scale on the pad-mounting clip. This vehicle may have had drilled and slotted rotors, but they would do little good if the rest of the brake system was not performing as designed or this vehicle was operating with restricted pad movement.

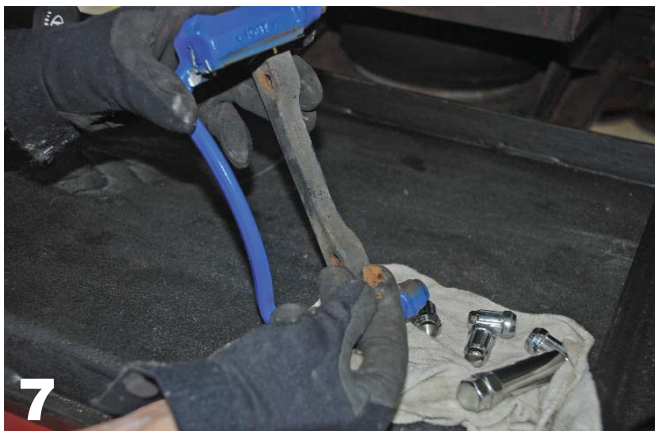
New caliper brackets frequently come with performance and other high-quality calipers. New brackets were part of the new calipers being placed on this vehicle, so the old one was removed. Note the piece of scale that was in the pad-mounting area of the bracket.

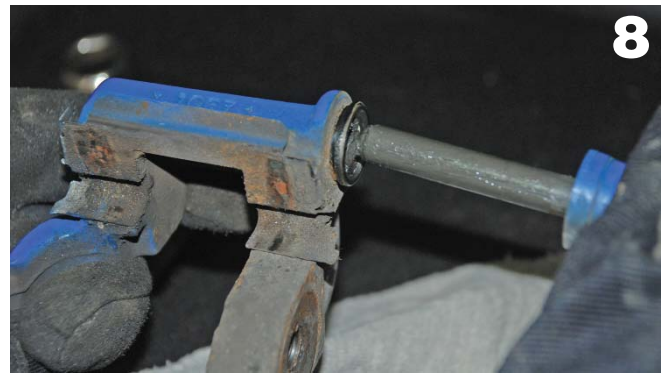
One part of this system that was OK was the caliper-mounting pins. There were lubricated and the dust seals were intact.

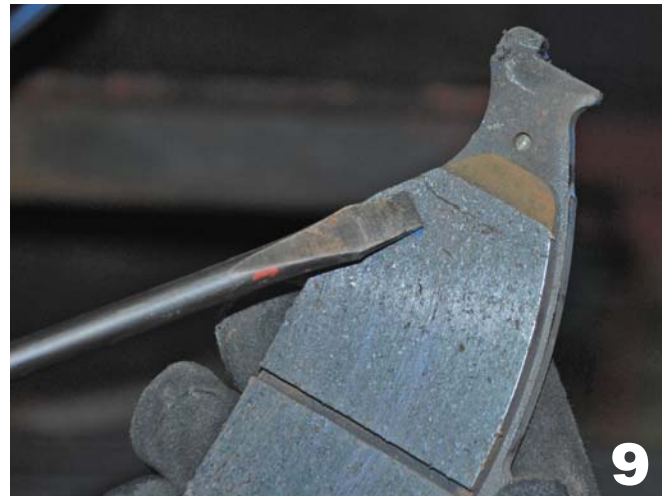
This picture really tells it all. The pad is cracked because of the high heat to which this brake has been subjected. The heat may have been due to pad drag resulting from binding caused by the rust, paint and scale, or the customer's driving habits may have been responsible – or both. In any event, the performance brake parts being installed will cure this condition.

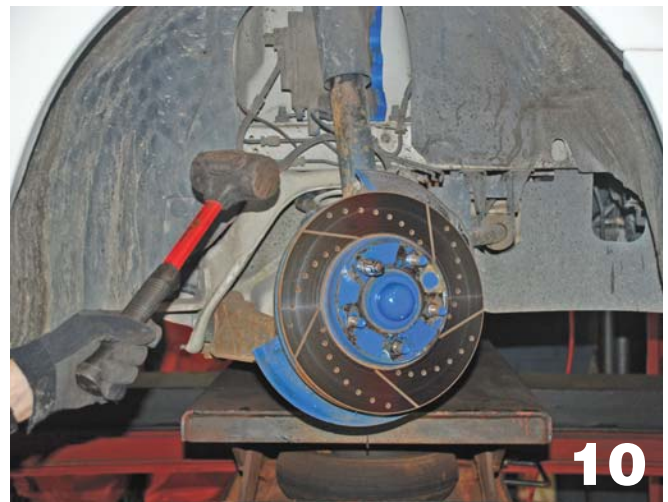
This Mustang uses slip-on/off rotors. Why, then, was beating the old rotor necessary to remove it? The reason was the rust and scale buildup around the center hole and on the backside of the rotor. This buildup also can easily cause a runout problem that will lead to brake-pedal pulsation.

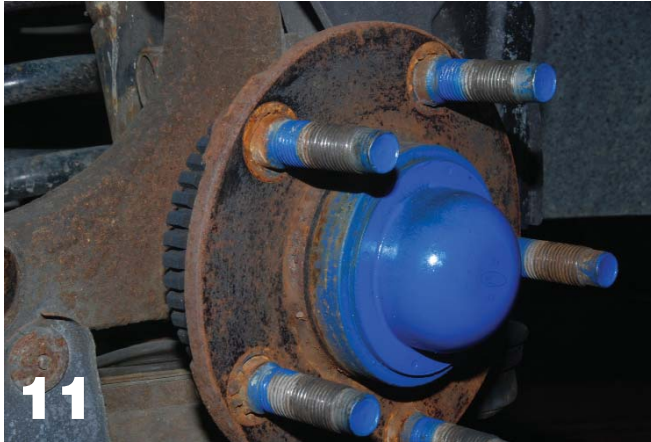
Look at the corrosion buildup around the studs. This must be cleaned up before installation of the new performance rotors. Failure to do so will surely cause a problem in the near future.

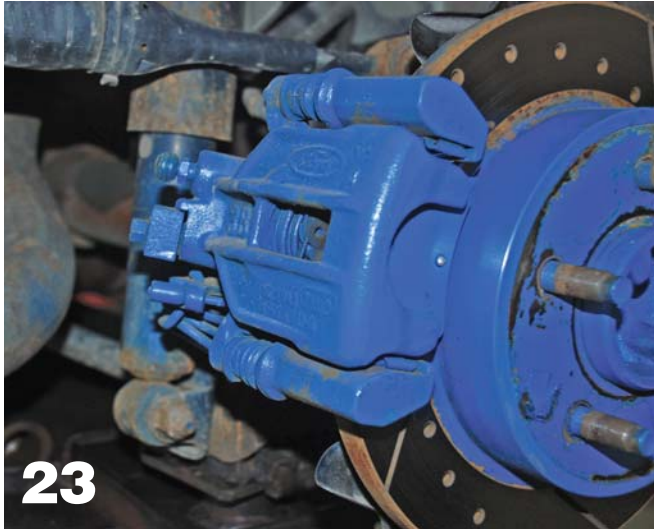
23

The rear brakes exhibited the same conditions found on the front.

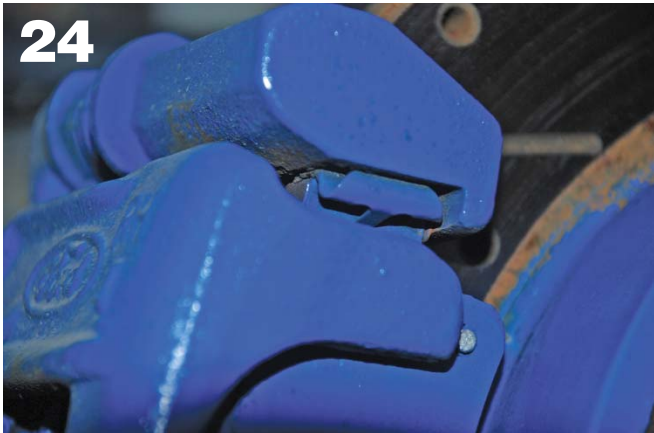
24

Look carefully at the anti-rattle-clip pad tensioner, indicative of the underlying rust problem.

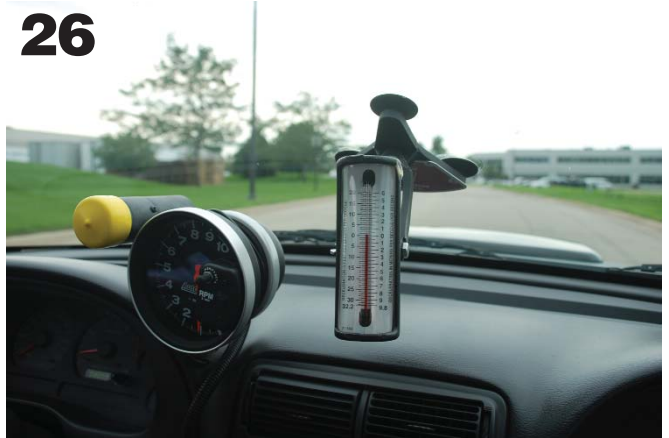
26

This windshield-mounted gauge measures deceleration in feet per second per second on the left scale and meters per second per second on the right. Although it's not as high-tech as a GPS computerized deceleration read-out or a dyno test, it does clearly show a vehicle's stopping ability in terms of deceleration rate.

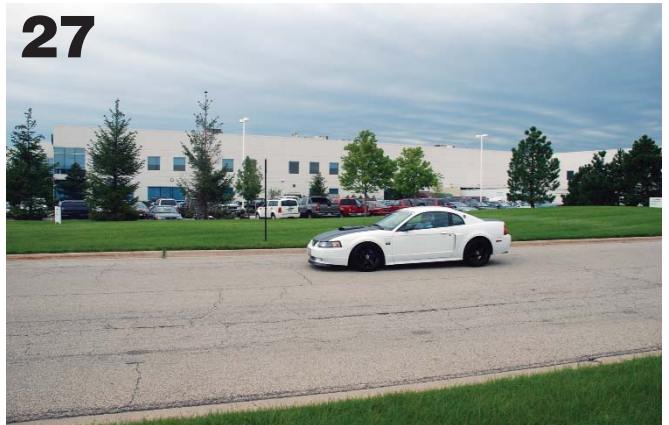
27

This photo shows the vehicle stopping before installation of the performance brakes. Note the vehicle's position relative to the building in the background.

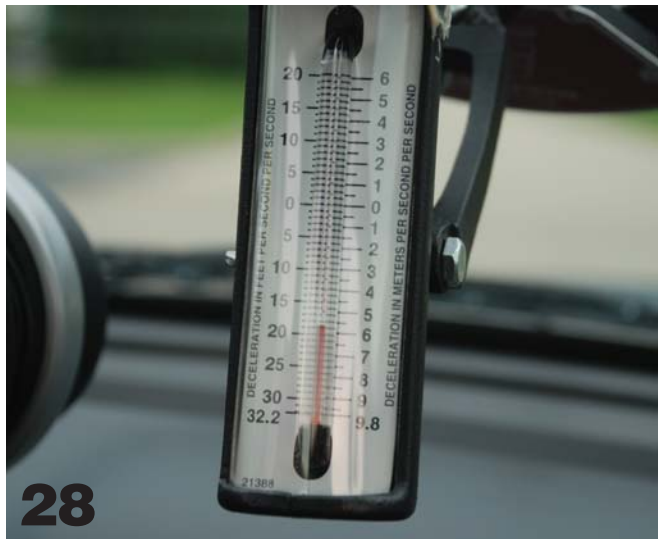
28

The gauge shows that the vehicle's best deceleration rate before the brakes were replaced was 19 feet per second per second.

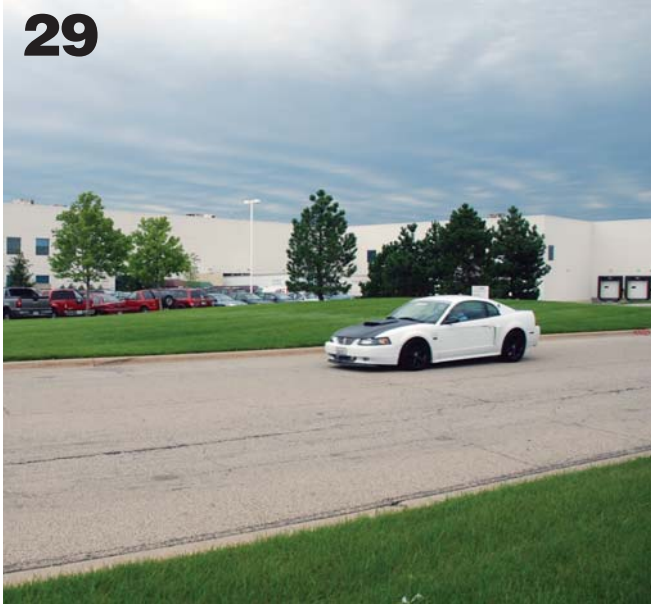
29

After brake replacement, you can see by the vehicle's position relative to the building that it stopped in a shorter distance.

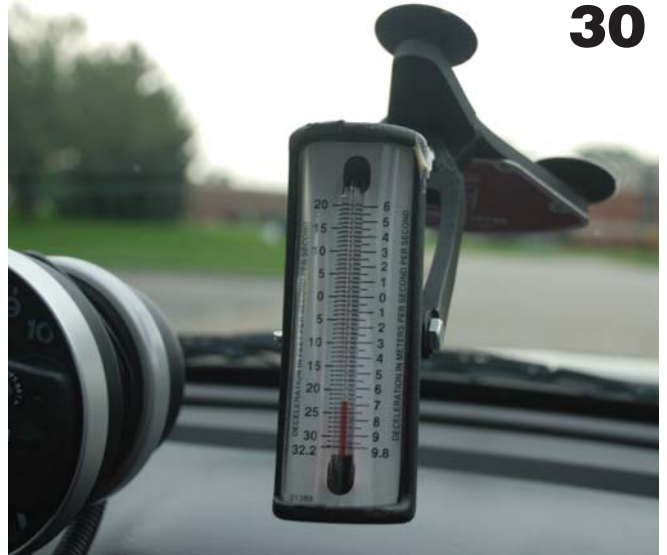
30

Deceleration after installation of the new brakes was 23 feet per second per second. This test was performed after only six 35-mph stops with the new brakes. After the brakes are seated in, there should be an additional 15% to 20% improvement. **UD**
